ALASKA DEPARTMENT OF ENVIRONMENTAL CONSERVATION
1994 STATEWIDE WATER QUALITY ASSESSMENT

NAME OF WATERBODY: Crow Creek

Describe Source and Nature of Pollution, Documentation Provided and Other Comments: Abandoned Mine Inventory
Brenner Mine workings and Millsite.

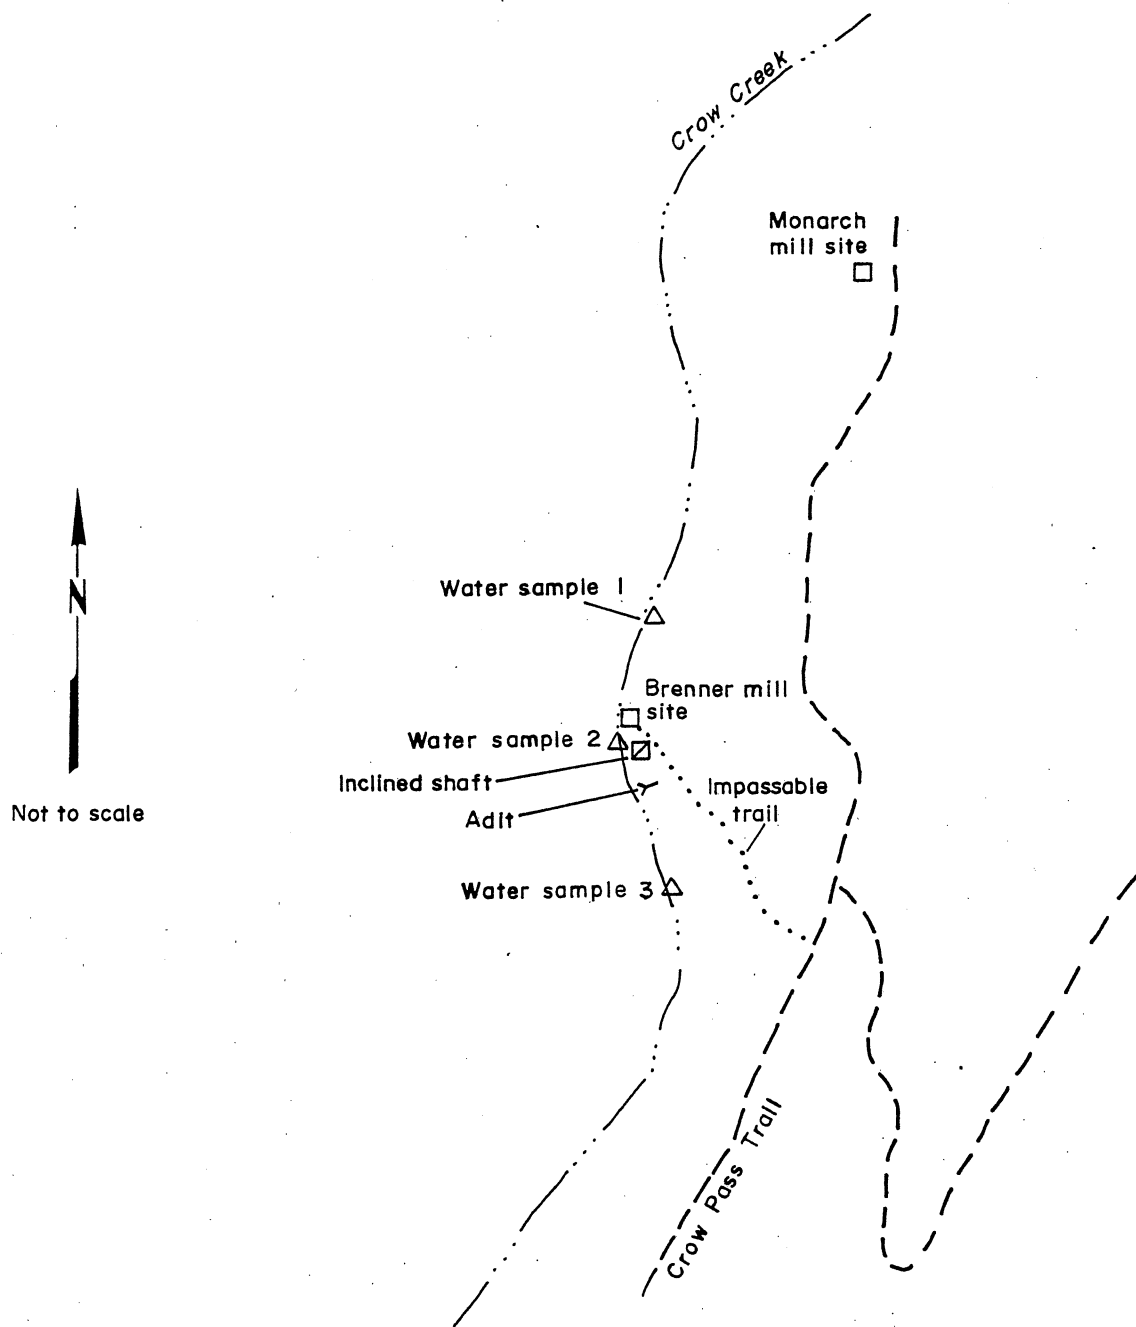
- 1) Sample 1- 100 feet upstream from the mill site,
- 2) Sample 2- next to the mill site, and
- 3) Sample 3- 100 feet downstream from the mill site. See figure 2.

These results indicate that the concentrations of arsenic and mercury are very low and do not change at all when passing by the mill site.

Figure 2.- Sketch map showing the main features of the Brenner Mine area and the locations of the water samples.
